Ground Vibration Report

| Event Date | 2026/05/31 |
| Location | Phoenix 3880 CYG 6450 |

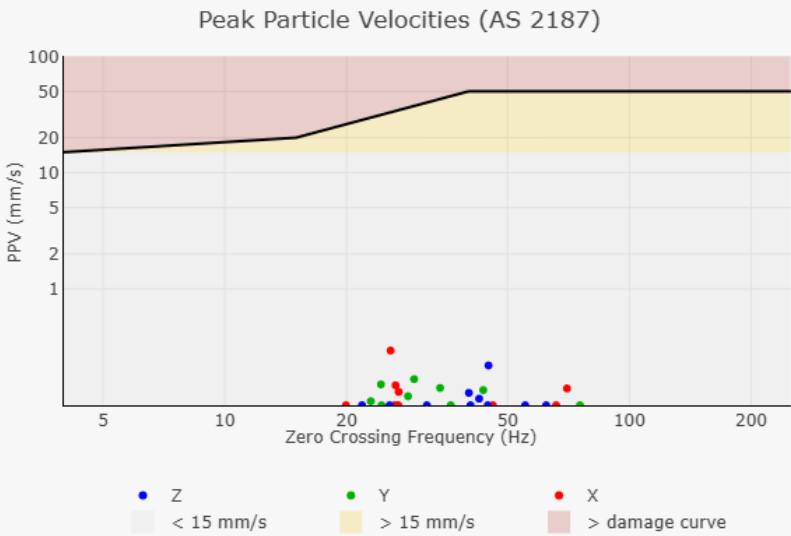
Per-component Peak Particle Velocities (PPV) vs. Zero Crossing Frequencies.  
Line indicates cosmetic damage guidelines  
(residential buildings, Fig. J4.4.2.1, AS 2187.2:2006).
