Ground Vibration Report

Summary

| Location | Phoenix |
| Notes | PHX 4010 CYG 6365 F2<br>Duration: 0.94s |

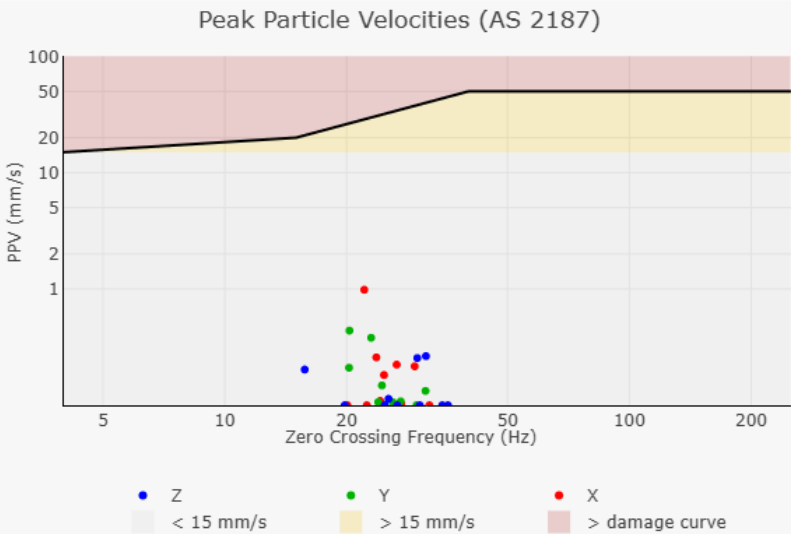
Per-component Peak Particle Velocities (PPV) vs. Zero Crossing Frequencies.  
Line indicates cosmetic damage guidelines  
(residential buildings, Fig. J4.4.2.1, AS 2187.2:2006).
