Ground Vibration Report

Summary

| Notes | Seismic event in the PHX 3690 PFC. 15m above drive. |

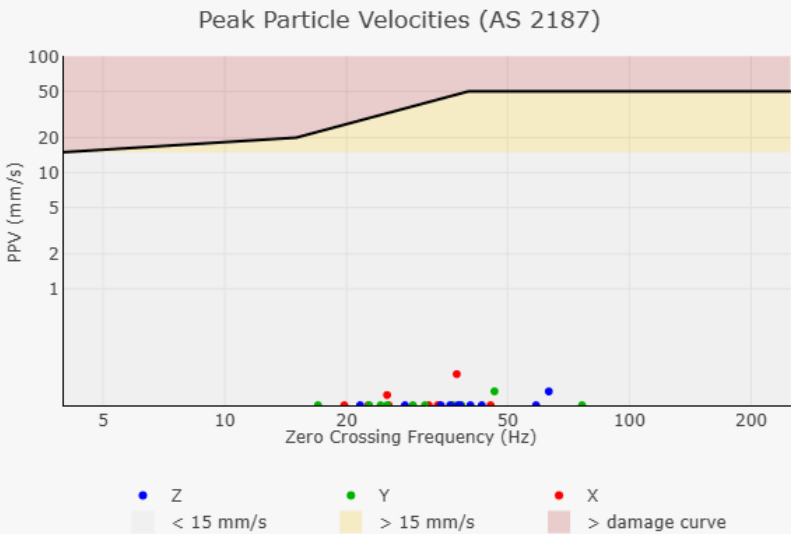
Per-component Peak Particle Velocities (PPV) vs. Zero Crossing Frequencies. Line indicates cosmetic damage guidelines (residential buildings, Fig. J4.4.2.1, AS 2187.2:2006).
