Ground Vibration Report

Summary

| Event Date | 2026/07/31 |
| Location | Phoenix |

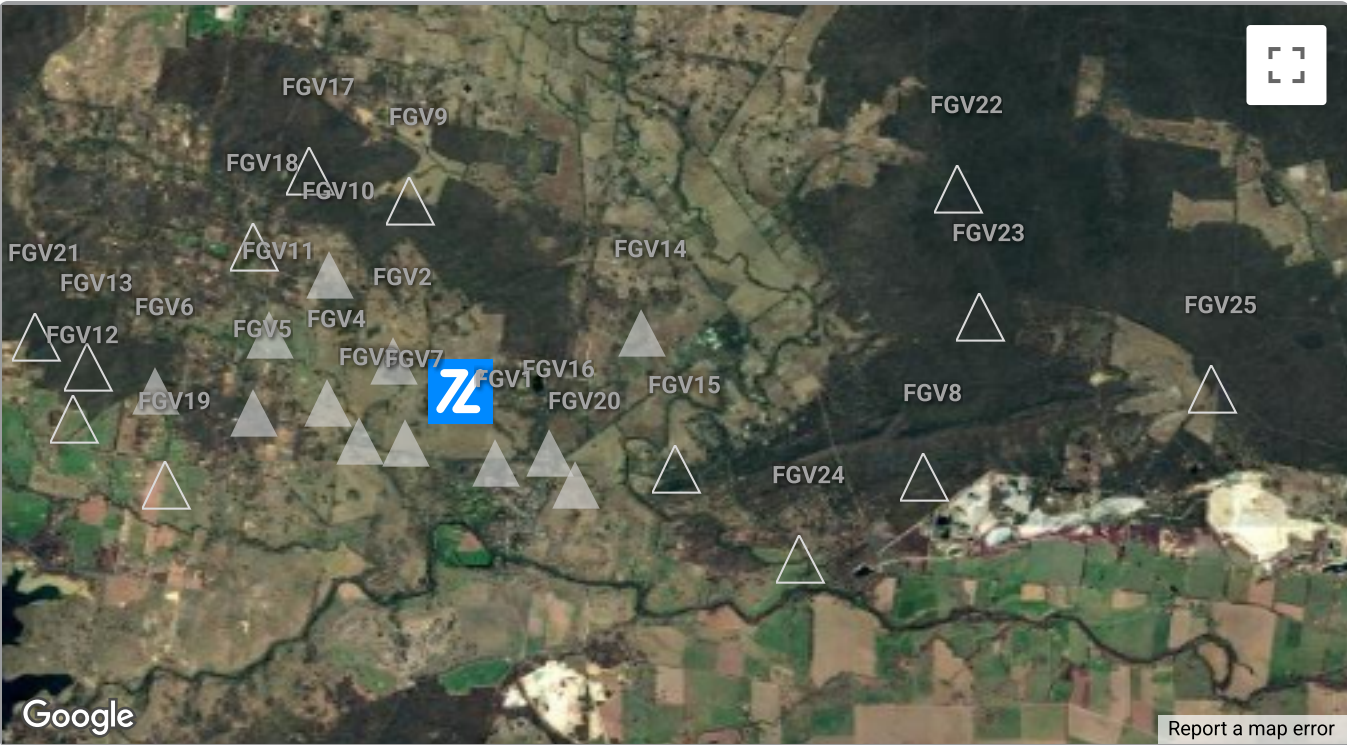
| Notes | 15m from PHX 3690 ACC |

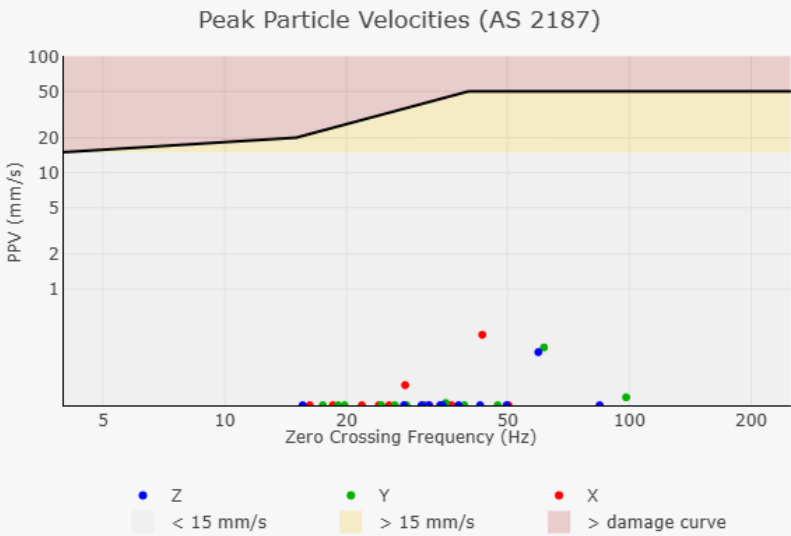
Per-component Peak Particle Velocities (PPV) vs. Zero Crossing Frequencies.  
Line indicates cosmetic damage guidelines  
(residential buildings, Fig. J4.4.2.1, AS 2187.2:2006).
